## Incident Report

File Number: 5467390  
Technology: Electrical  
Safety Officer: IAN HOWELLS  
Type of Premises: Single Family Residential

**Incident Location:** 2200 53rd Avenue  
**Area:** VERNON E OF 27TH ST/ HWY 97N

## Pictures from fire at 2250 – 53rd Ave Vernon

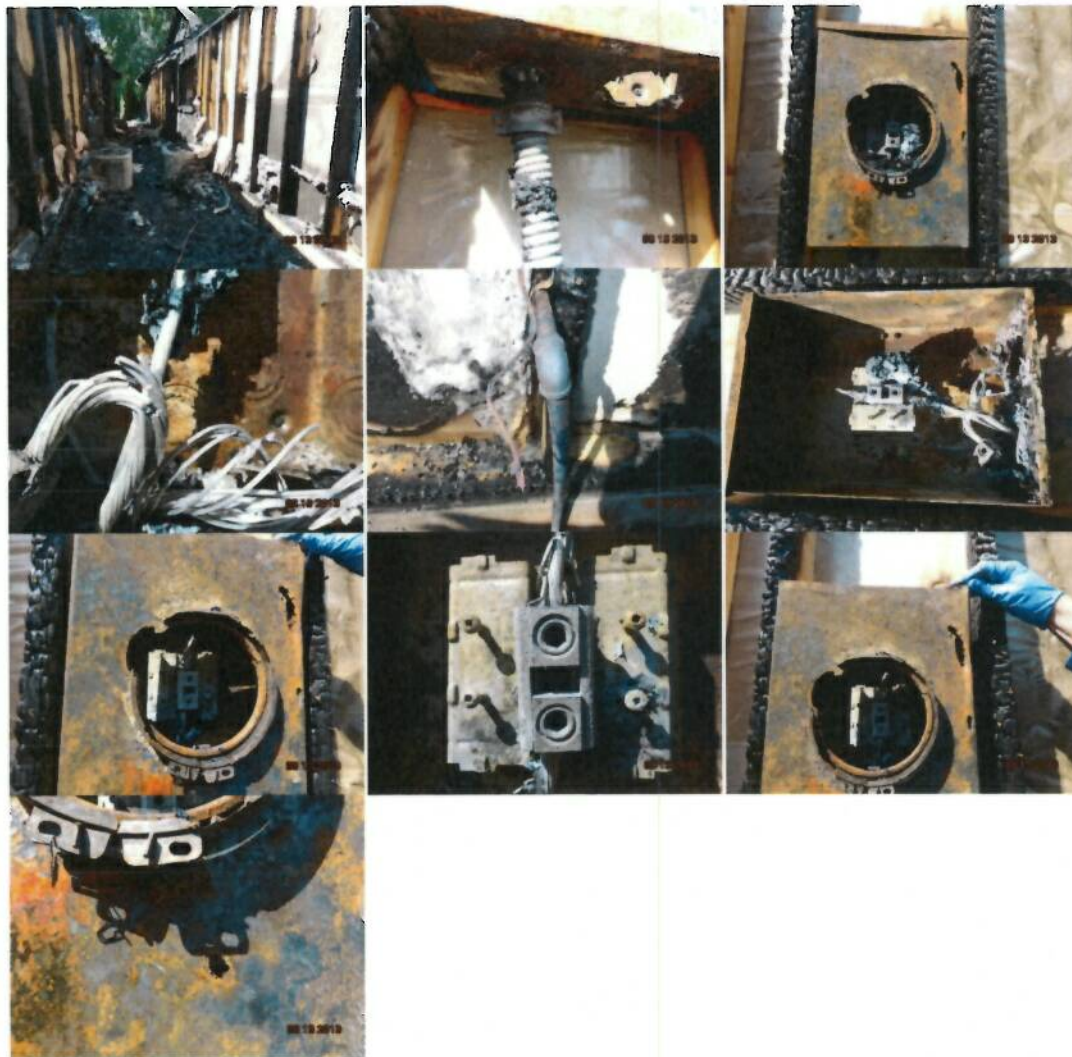
An arc-flash occurred in the meterbase of the residence located at 105 - 2200 53rd Ave Vernon. The ensuing fire completely destroyed the residence, and the adjacent residence # 106

The fire crossed a four foot walkway to # 106 and in the process, melted the gas meters located in the walkway, which added to the fire. Due to the amount of damage the cause of the arc flash was not determined.

The cause of this fire was an electrical failure in the meter base for this dwelling. Due to the amount of damage, the cause of this failure and the resulting arc flash was not determined

- 1) Walkway between houses
- 2) Service cable entrance (ACWU)
- 3) Micro-Electric Meterbase showing arc-flash damage
- 4) Service entrance conductor in meterbase
- 5) Gas Line entrance into residence
- 6) Meterbase (only the neutral connection is left)
- 7) More arc-flash damage at the meterbase
- 8) Neutral Connection
- 9) More arc-flash damage
